Test Report

Document No.: (3136/2315) – CM from 2nd of Decemer 2005

Subject: Testing the fire resistance of a load-bearing, room closing, 200 mm thick reinforced concrete slab with 100 mm thick Heraklith "Tektalan TK" segmented wood-wool panels; in combination with Hilti IDMS insulating pins with 80 mm retention plates in galvanized zinc-plated steel and Hilti IDMR insulating pins in A2 stainless steel (material number 1.4301) with 80 mm retention plates in galvanized zinc-plated steel, to determine the fire resistance rating for exposure to fire from the underside of the structure.

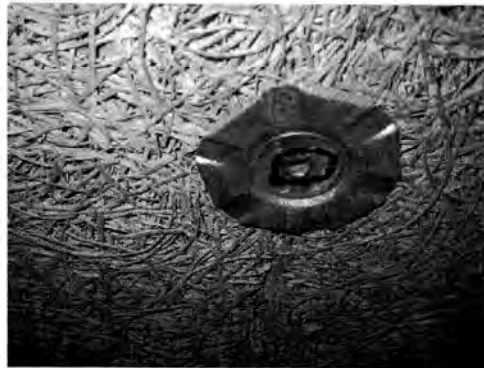
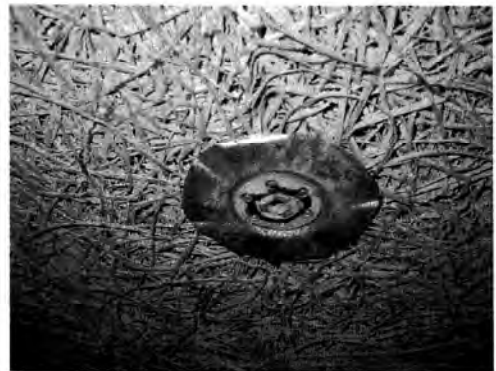
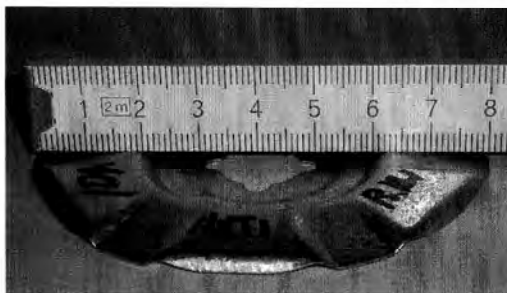
Pictures:1 Day before the Fire test

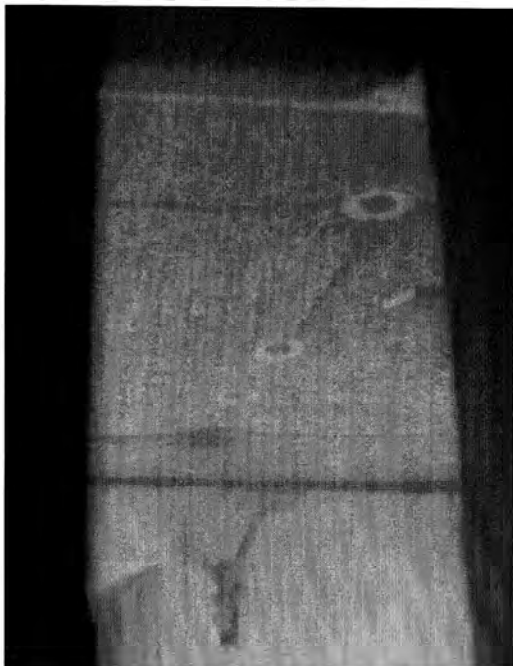
Pictures: During the Fire Test

Testing Length (min)	Side *)	Notices during the Fire Test on the 31st of March 2005
2	F	The panels are fading black.
10	F	The plates are drawing in the covering of the sheathing.
13	F	The gap opens up to 3mm.
24	F	The panels are clear again. The plates continued drawing in the covering of the sheathing.
29	F	The sheathing covers the anchor plates.
50	F	The panels are sagging round bodied between the anchors.
71	F	The panel (8) slowly starts to tilt (gap = 3mm).
75	F	The gaps of panel (7), (11) and (15) keep on rupturing.
77		Panel (8) fell down in the Fire room.
83		Panel (7) fell down in the Fire room.
87		Panel (11) fell down partial. Panel (9) is lying on a thermocouple.
93		Panel (6) fell down in the Fire room.
98		Panels (9), (10) and (14) have fallen down in the Fire room.
103		Panel (5) fell down in the Fire room.
110	-	End of flame impingement.

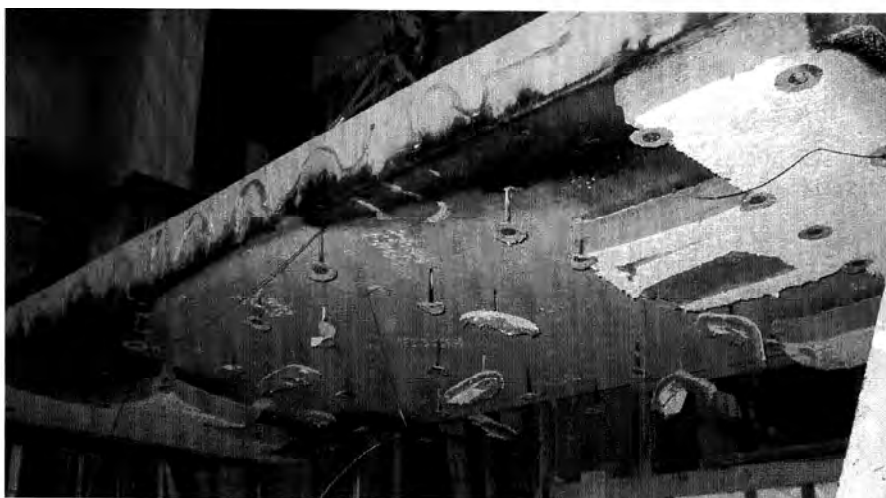
Pictures: 1 Day after the Fire Test

(3) The majority of the segmented wood-wool panels fell into the fire room. From then onwards the concrete slab was unprotected and therefore subjected directly to the heat.
